IMMEDIATE STOP USE AND INSPECT NOTICE FOR PARK TOOL CRANK PULLERS

PART NUMBERS AFFECTED: Park Tool [CCP-22](#), [CCP-44](#) and [CWP-7](#) Crank Pullers.

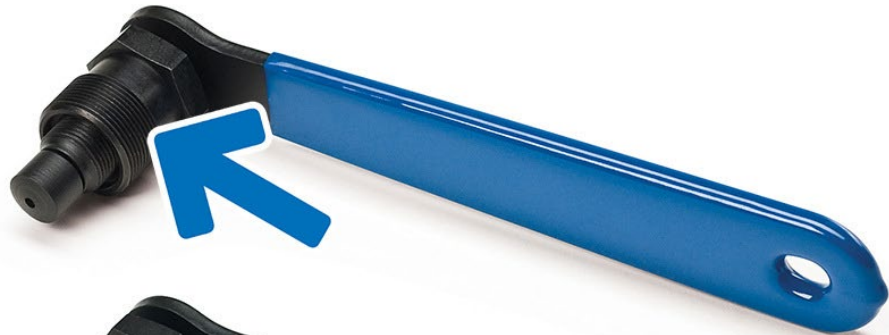
CCP-22

INSPECTION OF TOOL: To see if your tool is affected, locate the nut on each of the tools per the images below and inspect the threading.

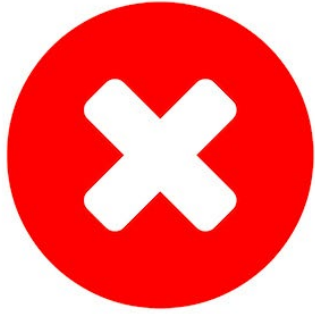
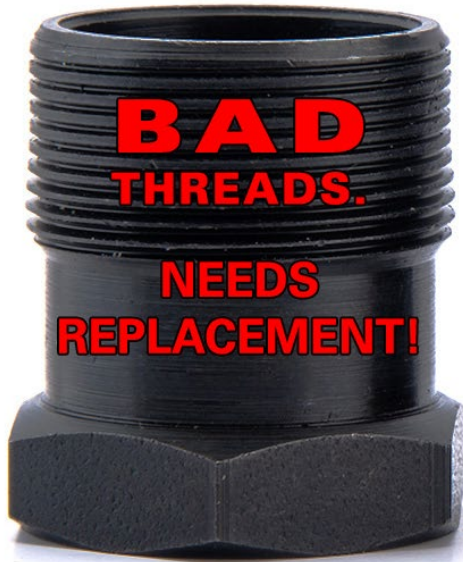
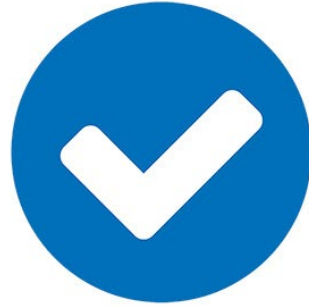
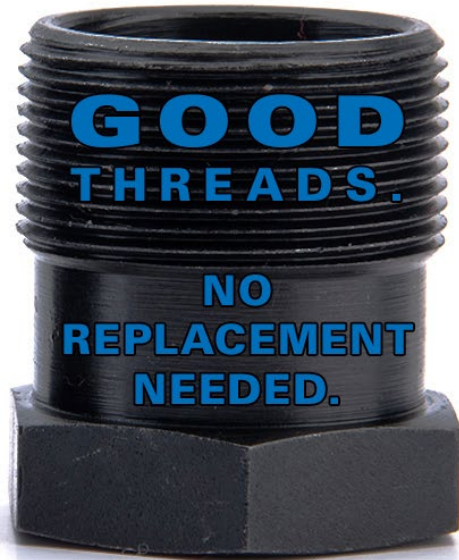
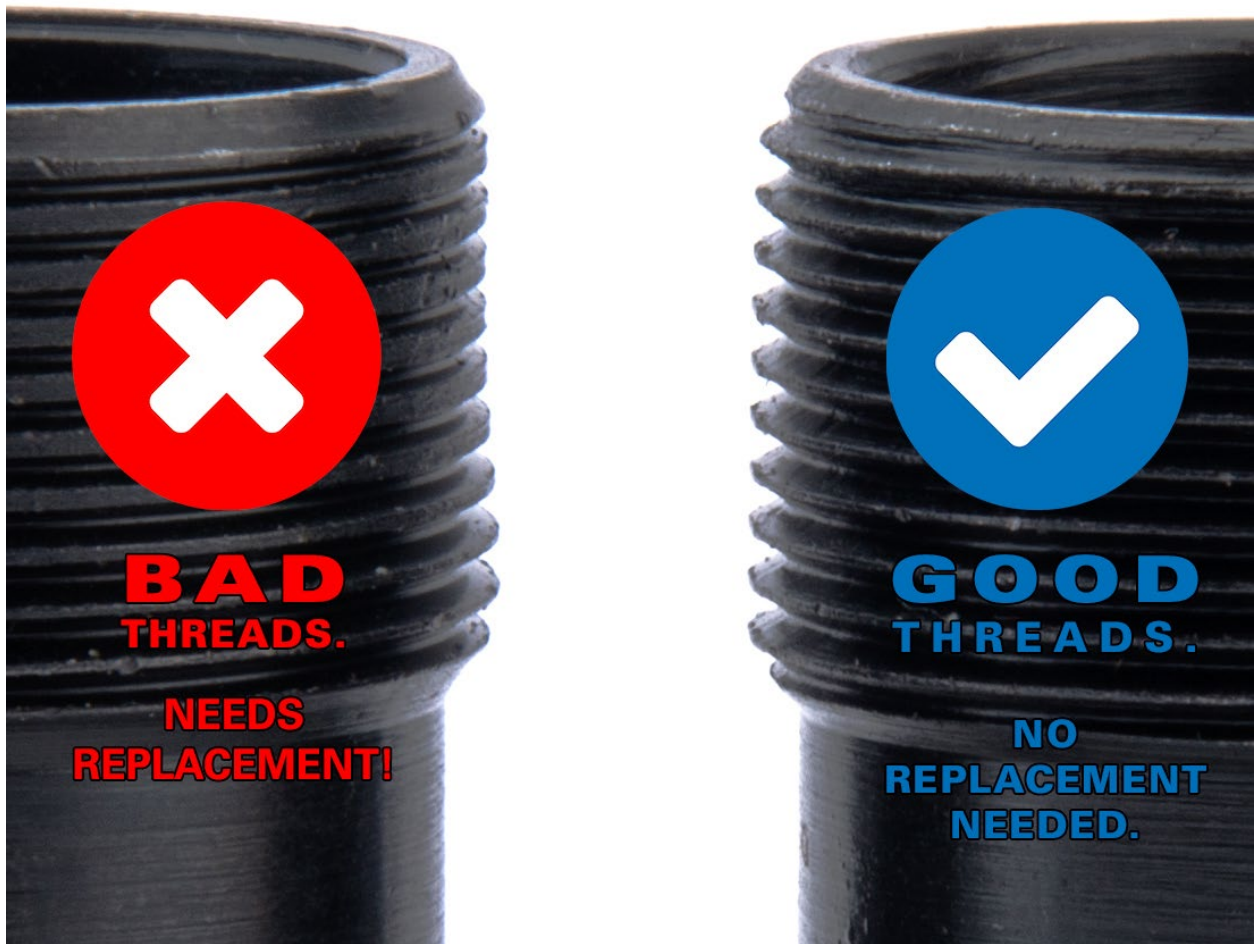
Bad threads will have a flat peak, and the improper thread peaks will extend almost halfway down the threading of the nut. The non-affected tools have sharper and consistent thread peaks throughout the length of the nut, as shown in the picture.

Park Tool will replace nuts with bad threads at no cost.

If you have inspected your puller, and have determined you need a replacement nut:
CUSTOMERS IN THE UNITED STATES: Visit parktool.com/1206, and follow the instructions.

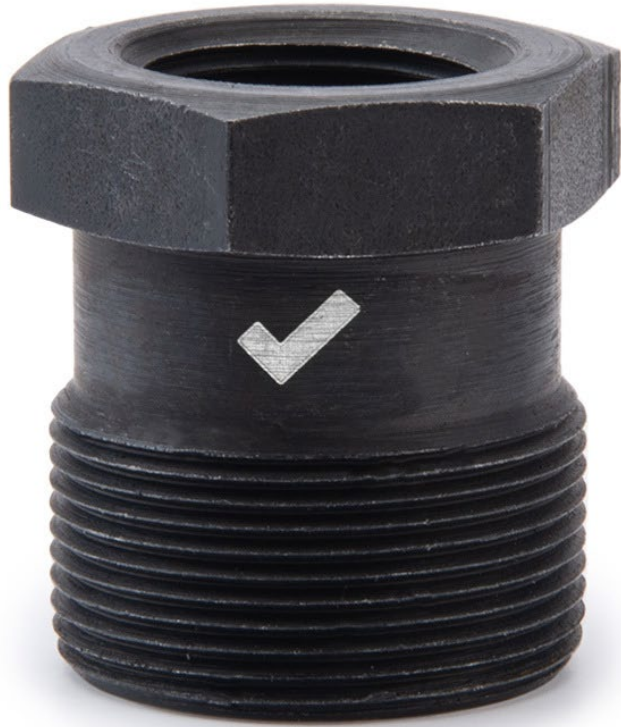
CRANK PULLER NUT WITH ENGRAVED CHECKMARK

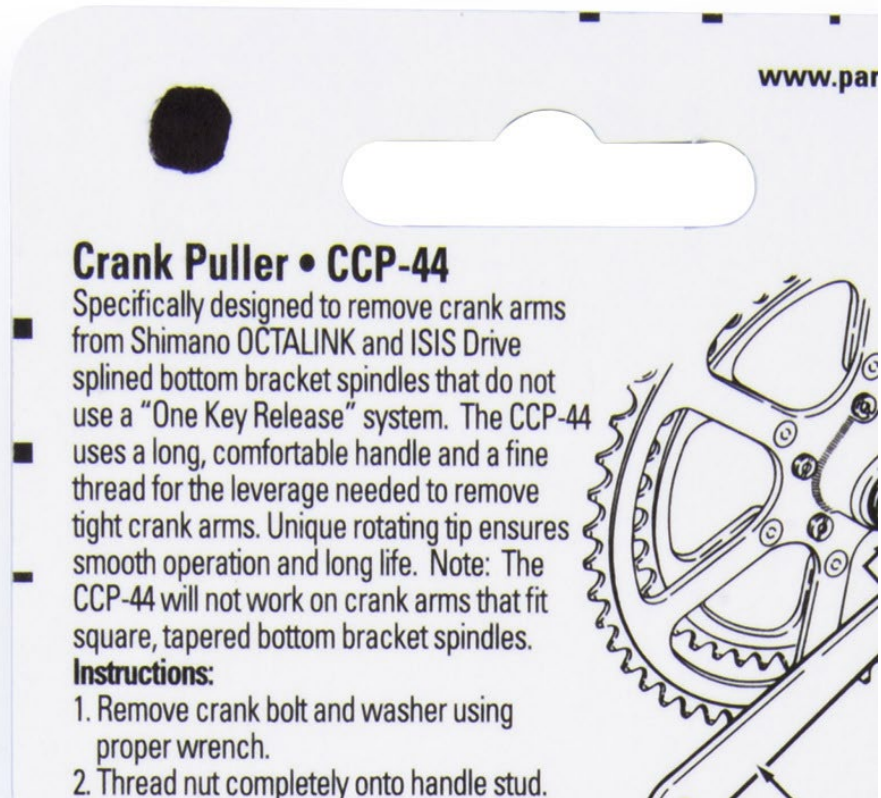
CRANK PULLER PACKAGING WITH DOT INDICATING TOOL IS GOOD
