# RECALL NOTICE

## PNW COMPONENTS RECALLS LOAM GEN 2 PEDALS

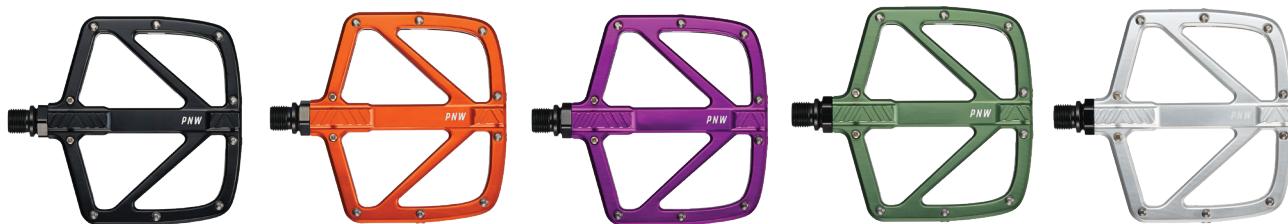
**HAZARD:** The pedal axle can crack, causing the pedal to detach from the crank, posing a fall hazard to the rider.

**RECALLED PRODUCT:** This recall involves the PNW Components Loam Pedal Gen 2 aluminum alloy mountain bike pedal. These pedals were sold after market through online retailers and bike shops. The pedal is a platform style (non-clip) pedal and can be identified by a “Tectonic” logo laser etched onto the pedal body on the left corner, on the same side as the threaded axle. The pedals are available in black, silver, green, orange, and purple.

**REMEDY:** Consumers should immediately stop using the Loam Pedal Gen 2 and contact PNW components to receive free replacement axles and instructions on replacement.
